MARINE SHIPPING INCIDENT

Great Barrier Reef Marine Park - Douglas Shoal

INFORMATION SHEET 3

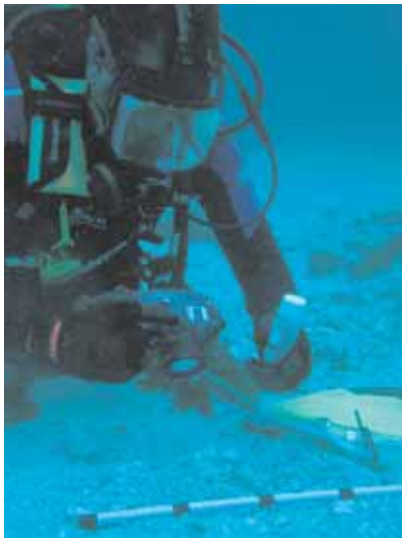
Diver sampling rubble bank
